**ULTRA HIGH DENSE MEDIA SEPARATION
PLANT (UHDMS)**

REPORT NUMBER: REP032023-004

INSPECTION – 14 WEEKS IN OPERATION

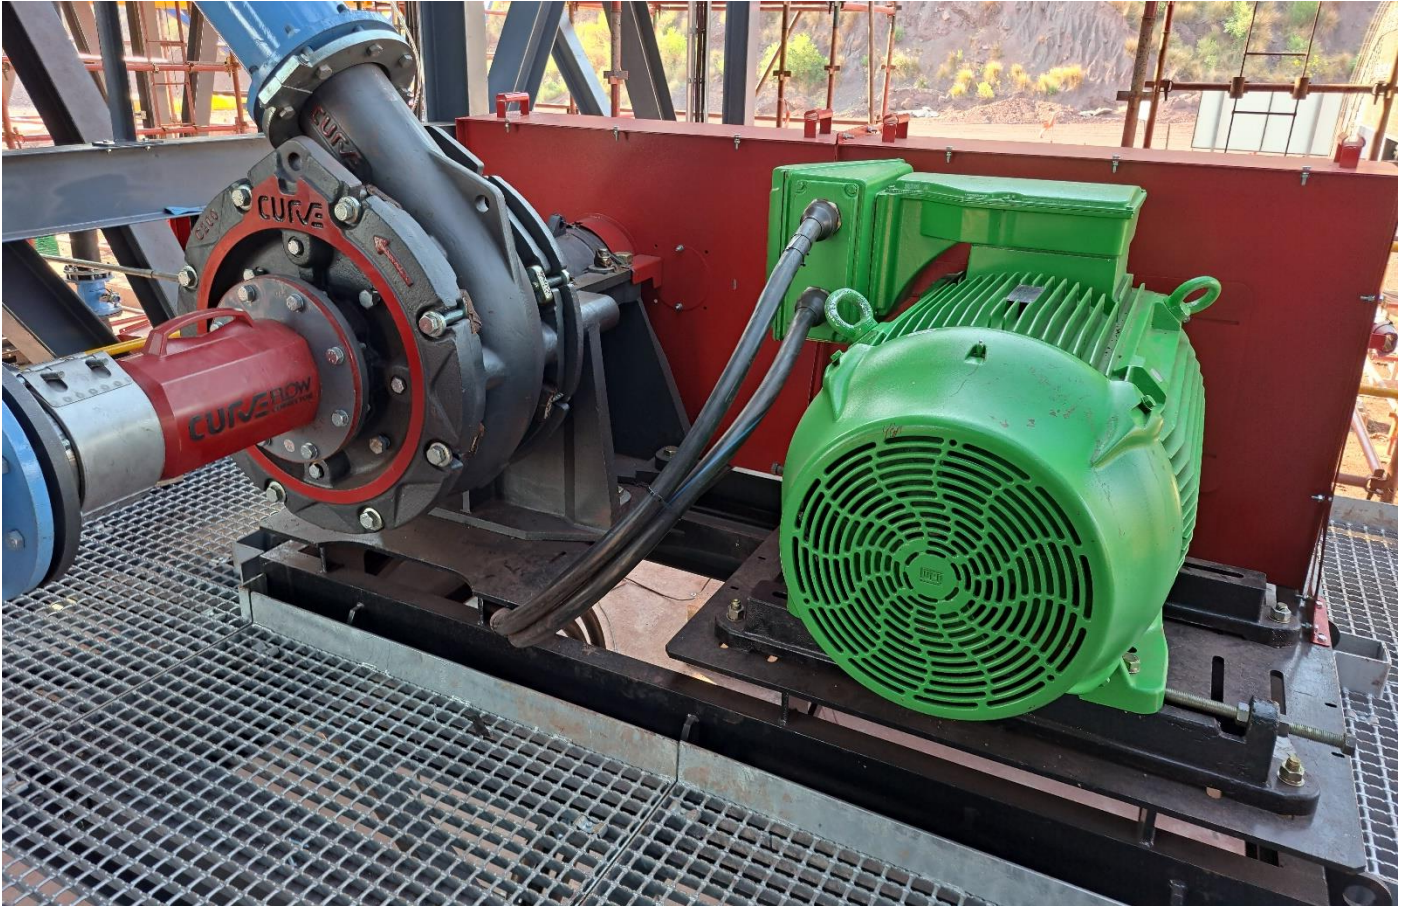
Figure 2 - Cyclone Feed Pump

The image below depicts the cyclone feed pump installed at the Ultra High Dense Media Separation Plant installed by Consulmet at the Gravmax plant in Thabazimbi.

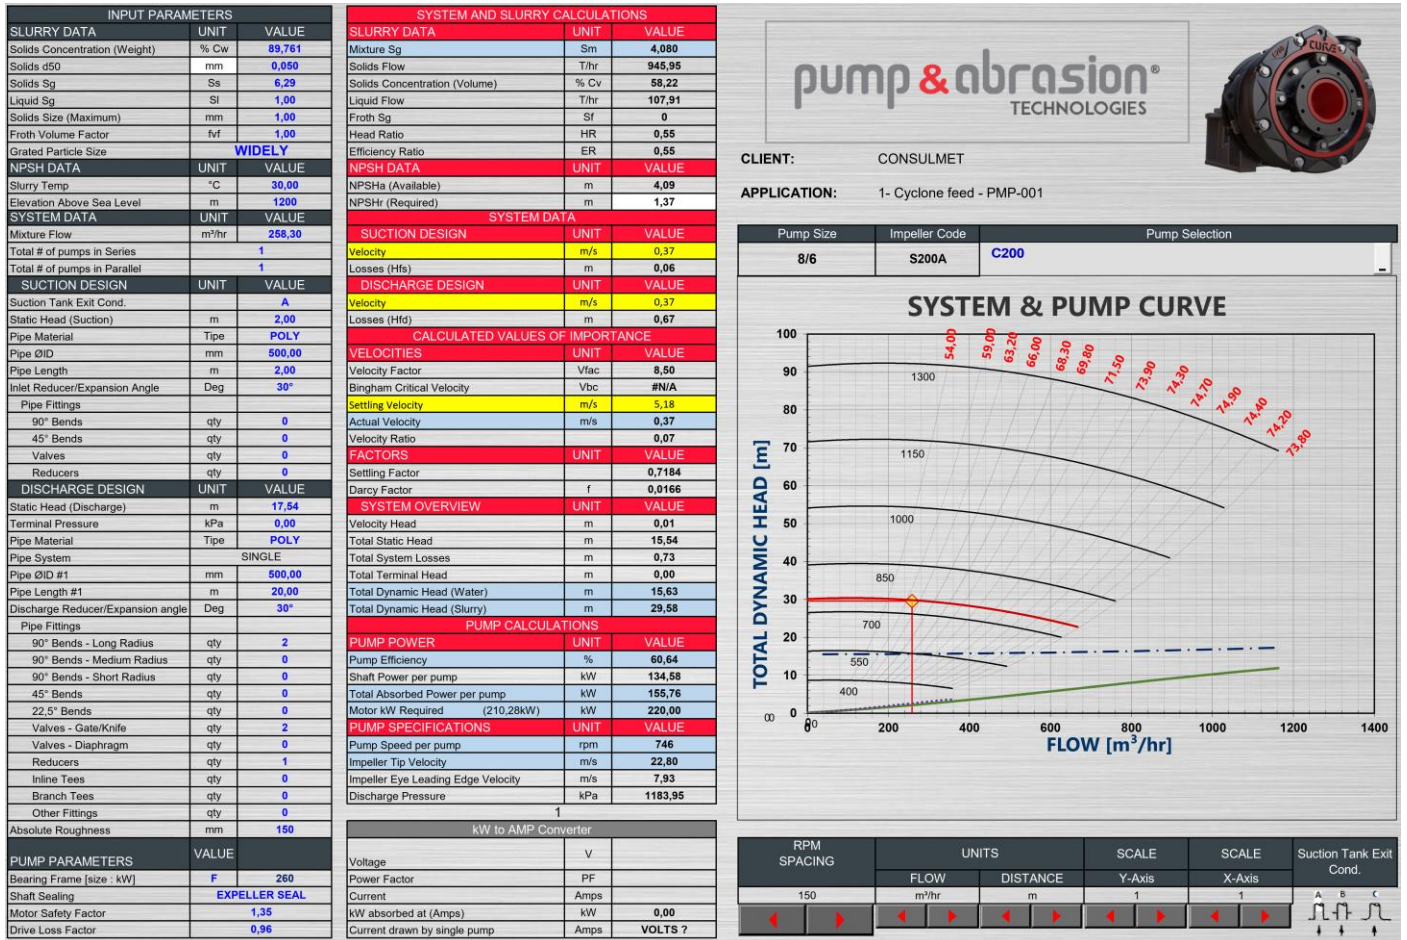
Figure 3 – Pump Performance Curve

The performance curve above highlights the following performance characteristics.

PERFORMANCE PARAMETERS	
PERFORMANCE PARAMETER	VALUE
Flow Rate	258.30 m³/hr
Power Absorbed	155.76 kW
Motor Size Required	220 kW
Pump Speed	746 RPM
Pump Efficiency	60.64%
Impeller Tip Velocity	22.80 m/s

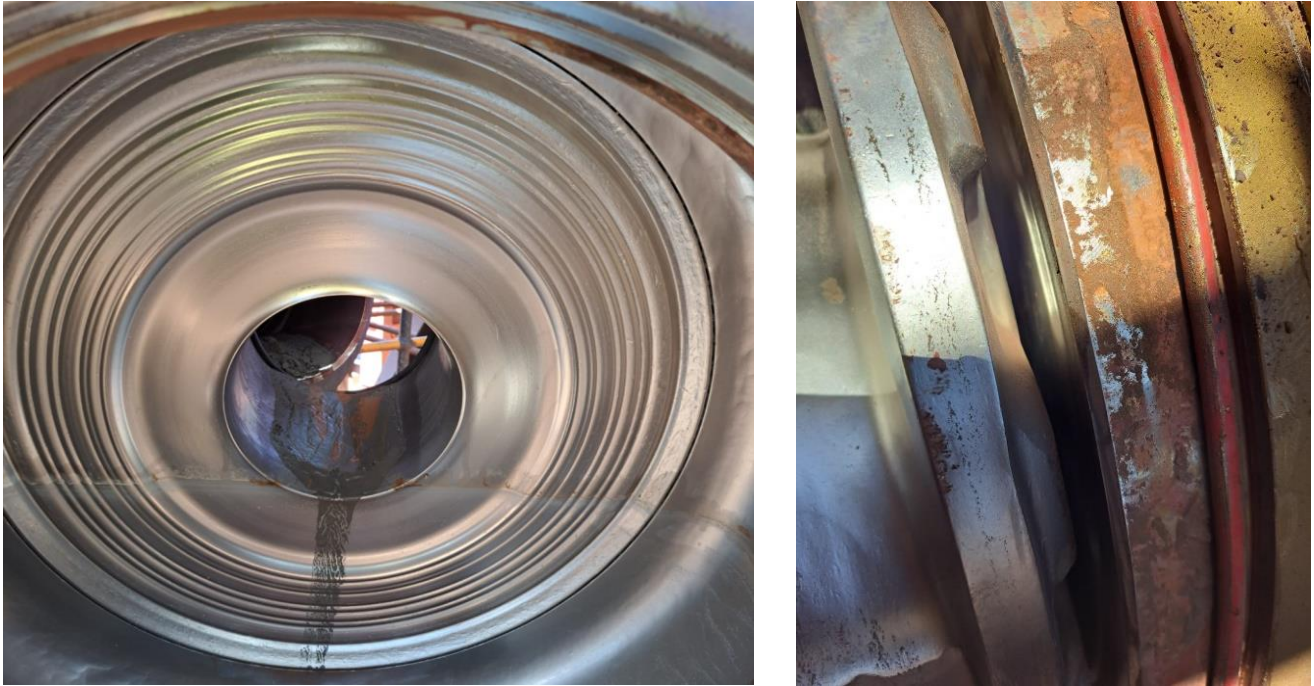
Figure 4 - Cyclone Feed Pump Suction and Drive Liner

The suction liner has a clean, uniform, groove-like wear pattern. The sealing edge between the casing and suction liner is completely intact and unworn. There was little to no change in the wear from the first inspection to the second. The deep groove-like wear can be accounted for by the oversize particles that enter the pump from the primary screen, which get trapped between the suction liner and impeller in the pump out vanes where they gouge into the impeller and suction liner, the same pattern can be seen on the drive liner and the impeller. The wear on the suction liner is relatively uniform across the complete surface of the suction liner and therefore the complete wear surface of the liner can be used.

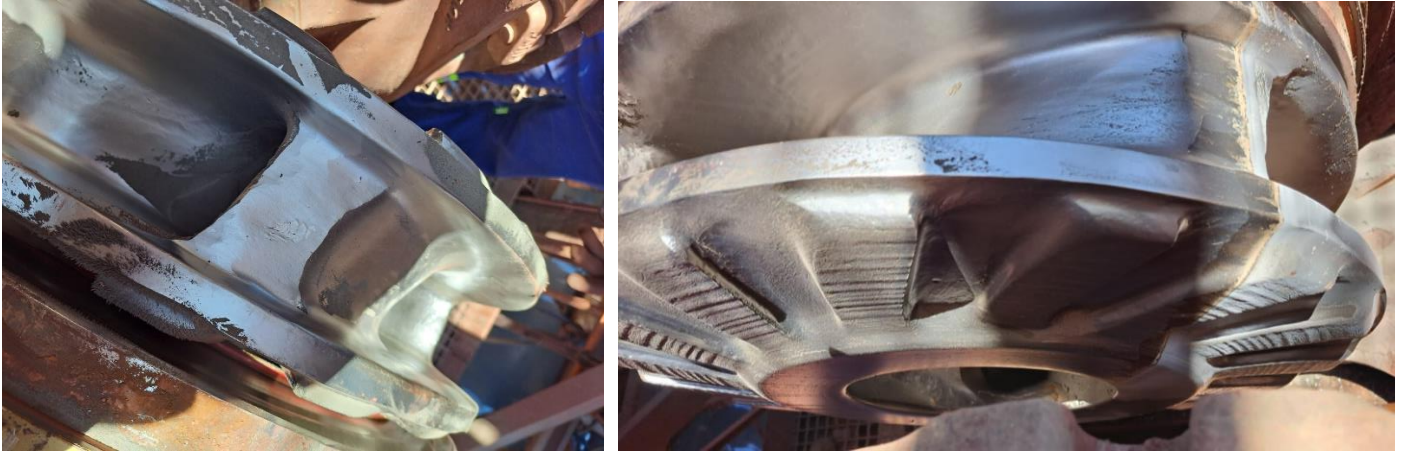
Figure 5 - Impeller wear

Minimal impeller wear is visible, the shrouds have not lost much thickness. The primary vane tips are in good condition but have some minor wear. The impeller eye is unworn and there is no sign of the impeller vanes thinning.

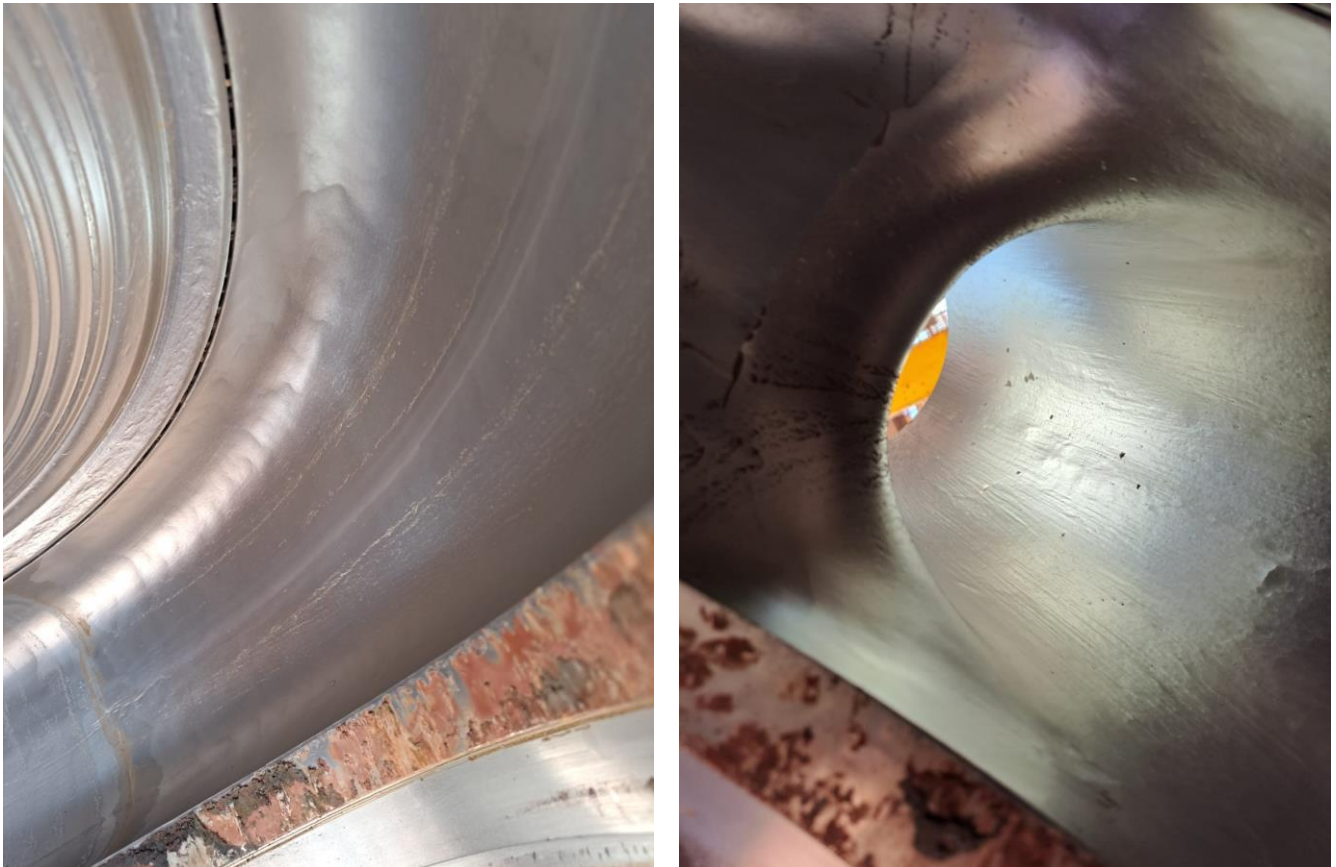
Figure 6 - Casing and Cut Water Wear

The volute/casing shows minimal signs of wear and is still in very good condition.

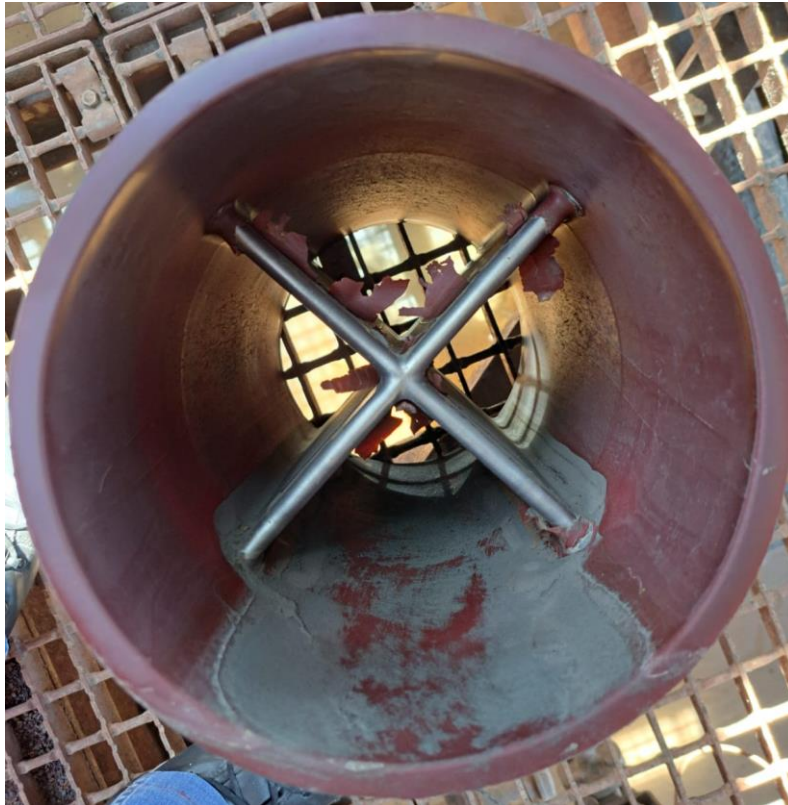
Figure 7 - Flow Corrector Wear

The above image highlights the wear on the Flow Corrector™. The wear is negligible as the only wear present is the polyurethane coating peeling off the chrome cross. The Flow Corrector™ has performed excellently, this is evident in the way the eye of the impeller has no wear.

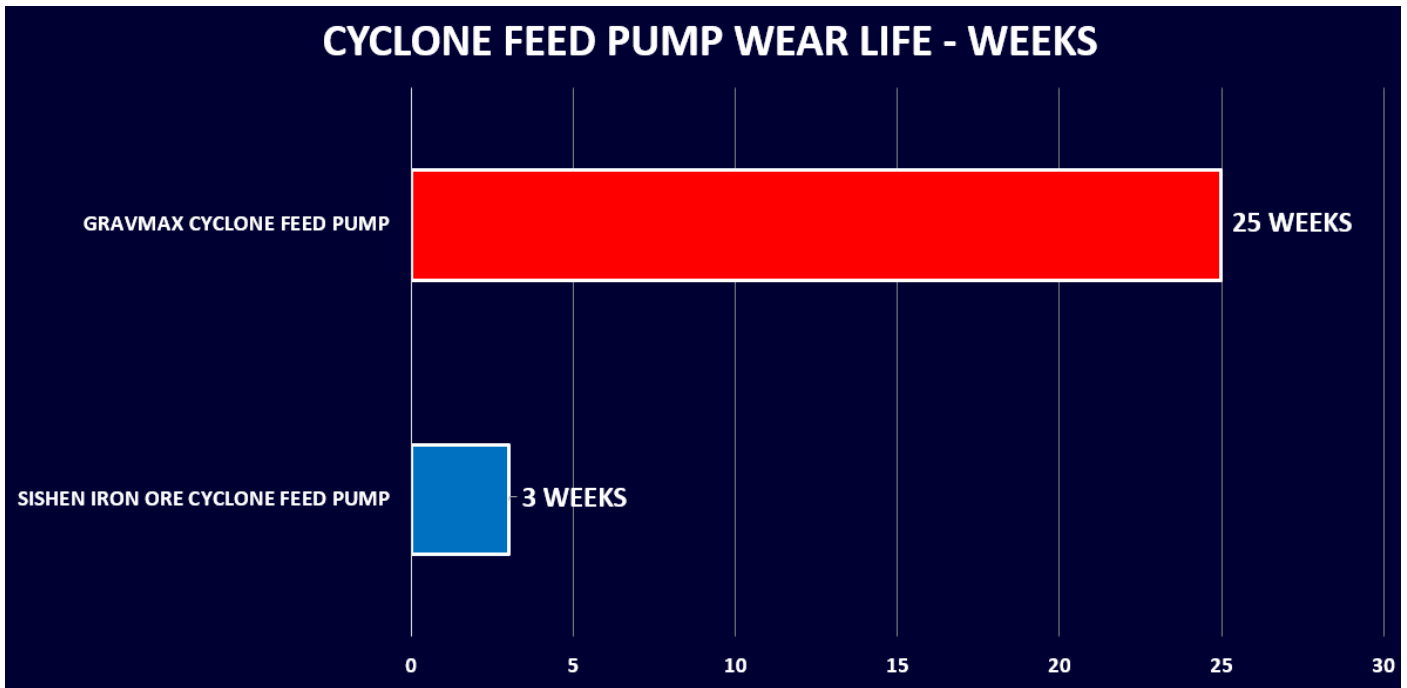
Figure 8 - Comparative Wear Life

WEAR LIFE PREDICTION	
COMPONENT	WEAR LIFE
IMPELLER	30 WEEKS
CASING	30 WEEKS
SUCTION LINER	20 WEEKS
DRIVE LINER	20 WEEKS

The Above prediction results in an average component wear life of **25 Weeks**. The below figure represents the comparative wear life of the Sishen and the newly completed plant.
